Report on the investigation of the
keel failure and capsizing of
the Comar Comet 45 Sport yacht
Tyger of London

1 nautical mile south of Punta Rasca, Tenerife
on 7 December 2017

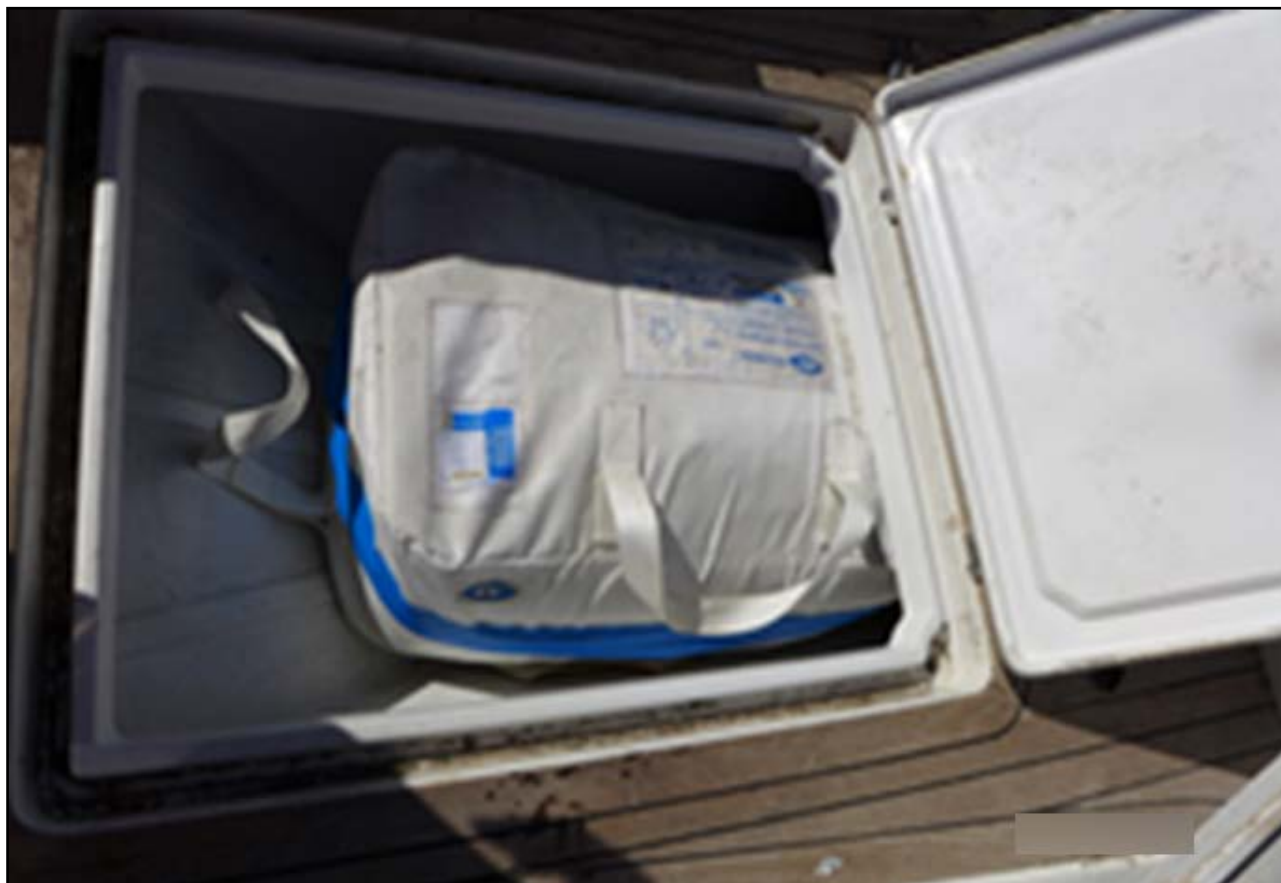
- An 8-person liferaft (without SOLAS pack); post-accident, the yacht's valise liferaft was found in its stowage locker below the cockpit floor (**Figure 12**).

Figure 12: *Tyger of London's* valise liferaft, post-accident, in its cockpit locker

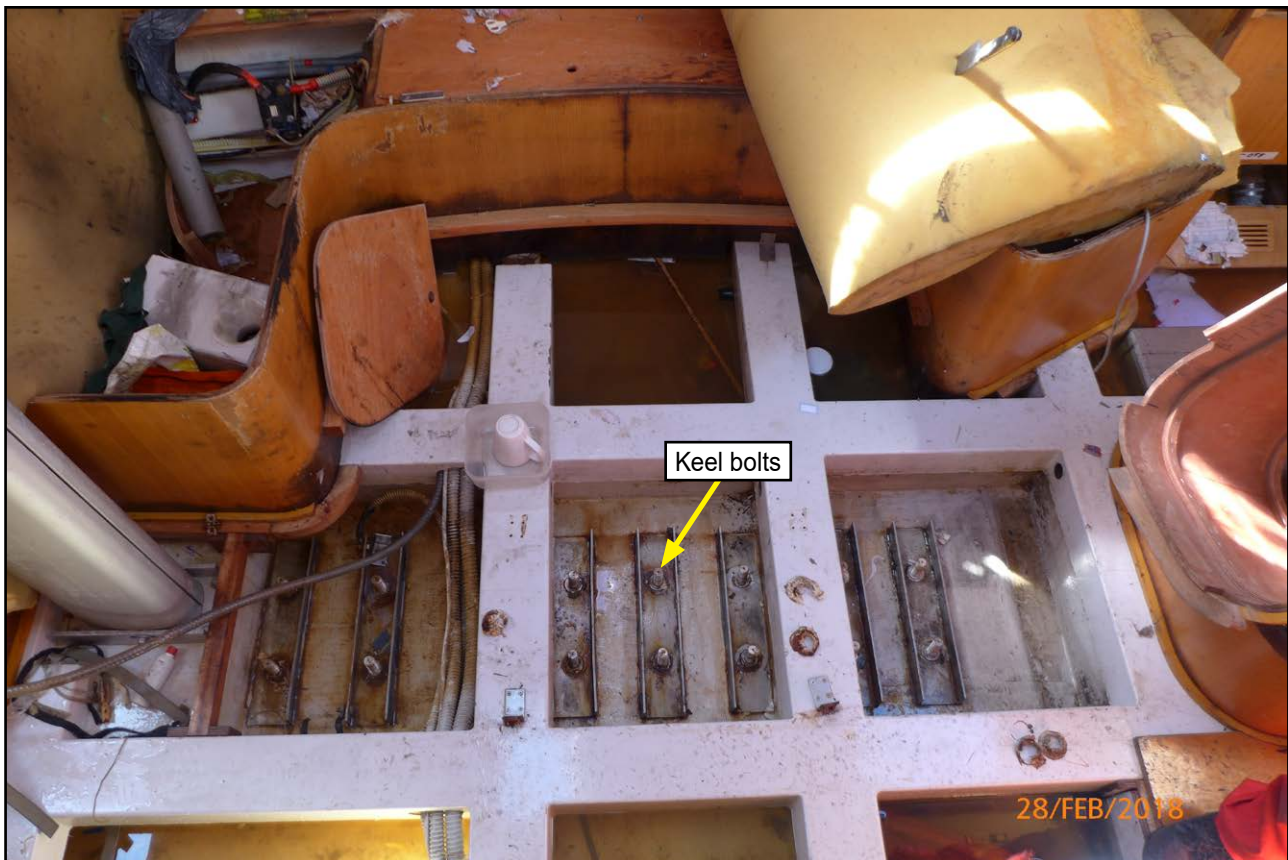
The internal structure of the hull and the keel matrix was found to be in good condition (**Figure 13**). There was no sign of cracking or damage around any of the internal beams. Externally there were no signs of damage to the hull. The keel plate was removed by the MAIB and shipped to the UK for technical examination.

Figure 13: The keel matrix (bolts removed by surveyor prior to keel plate removal)

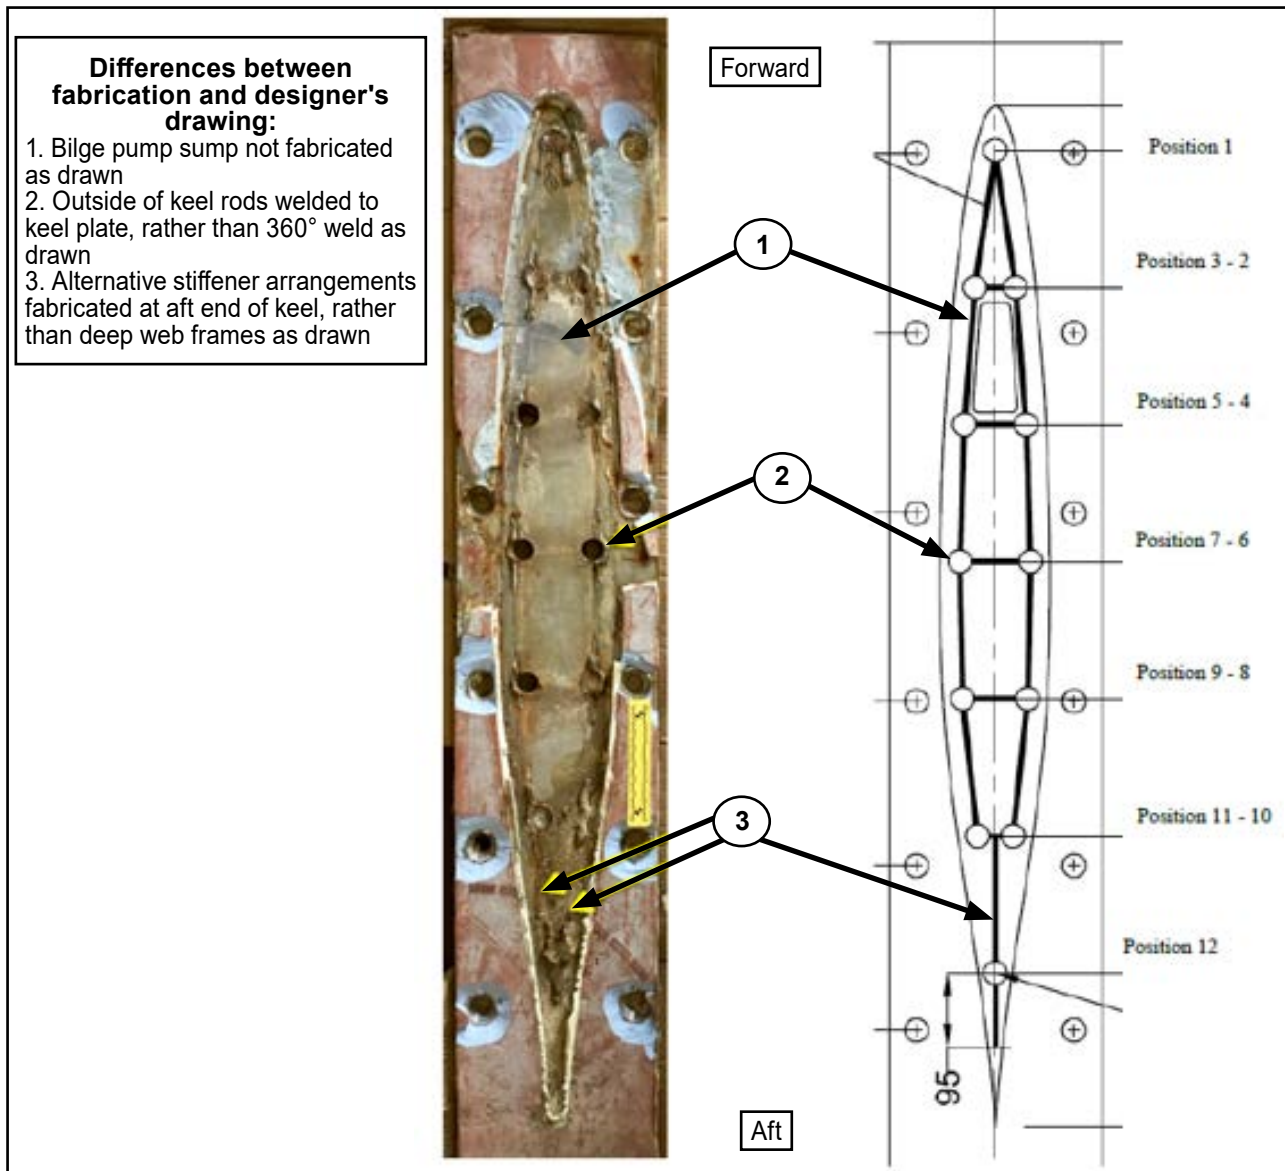
The report concluded that the most likely sequence of failure was that threads on rods 6 and 7, under the heaviest load, began to strip (**Figure 14**). Thereafter, cyclic loading gradually increased the lateral movement between the keel and its top plate. Once these two rods shed their load, the remaining rods steadily failed until the keel fin detached from the keel plate.

Figure 14: *Tyger of London's* keel plate noting differences between recovered keel plate and designer's drawing

The examination of the keel top plate revealed that the stainless steel frame of *Tyger of London's* keel had not been constructed in accordance with the designer's drawings. Most critically, the complex design made it difficult for the fabricator to manufacture the keel frame in accordance with the designer's drawings. As a result, the manner in which the keel rods were welded to the underside of the keel plate was changed. This undocumented change, albeit made in discussion with the shipyard, resulted in less than 50% of the keel rods' circumference being welded as they passed through the underside of the top plate. However, the shipyard did not consult the yacht designer over these changes. Additionally, when the quality of the welds was examined it revealed that a number had fillet leg lengths of 4-7mm when the minimum should have been at least 8mm.

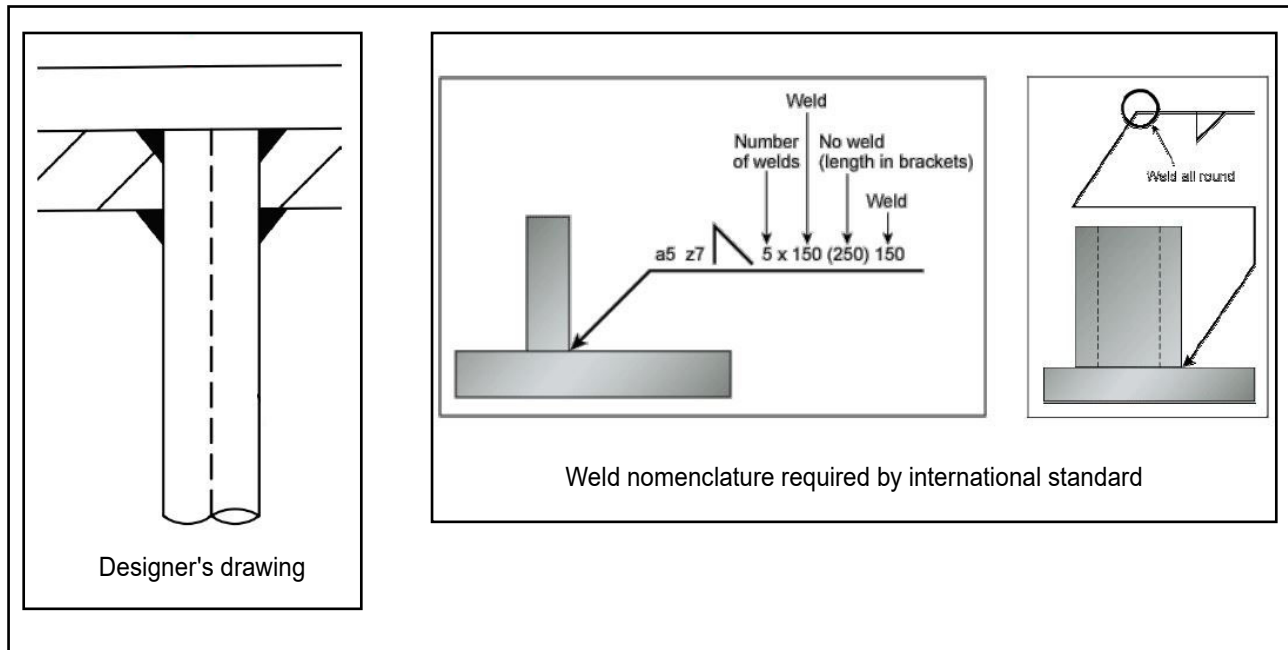
A further element missing from the keel drawings was detailed guidance on the welds fixing the keel rods and keel plate. Typically, the designer would provide standard notation (ISO 4063-Welding and applied processes-nomenclature of process and reference numbers), which would detail the weld throat size and leg length for this critical element of this keel's construction (**Figure 16**). The Wolfson Report also noted that the design did not take into consideration the access required by the fabricator to achieve an adequate weld with each keel rod in place; a practicality that led the fabricator and shipyard to modify the design.

Figure 16: Comparison between designer's drawing and weld nomenclature required by international standard
