Report on the investigation of the
capsize and foundering of the fishing vessel

Nancy Glen (TT100)

Lower Loch Fyne, Scotland

18 January 2018

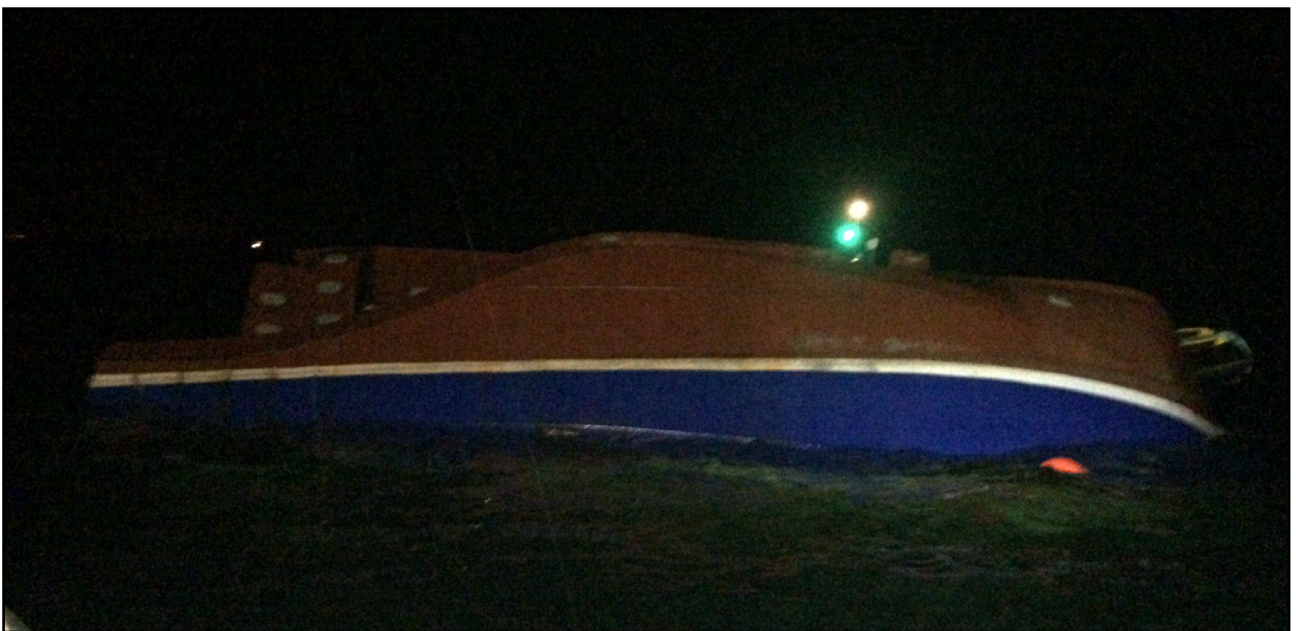
Figure 2: *Nancy Glen's* upturned hull

As *Nancy Glen* rolled over, one crewman was able to escape from the accommodation, scramble across the main deck and jump over the vessel's stern; the remaining crewman and the skipper remained trapped in the upturned hull. The vessel then foundered by the stern and sank to the seabed in approximately 143m of water.

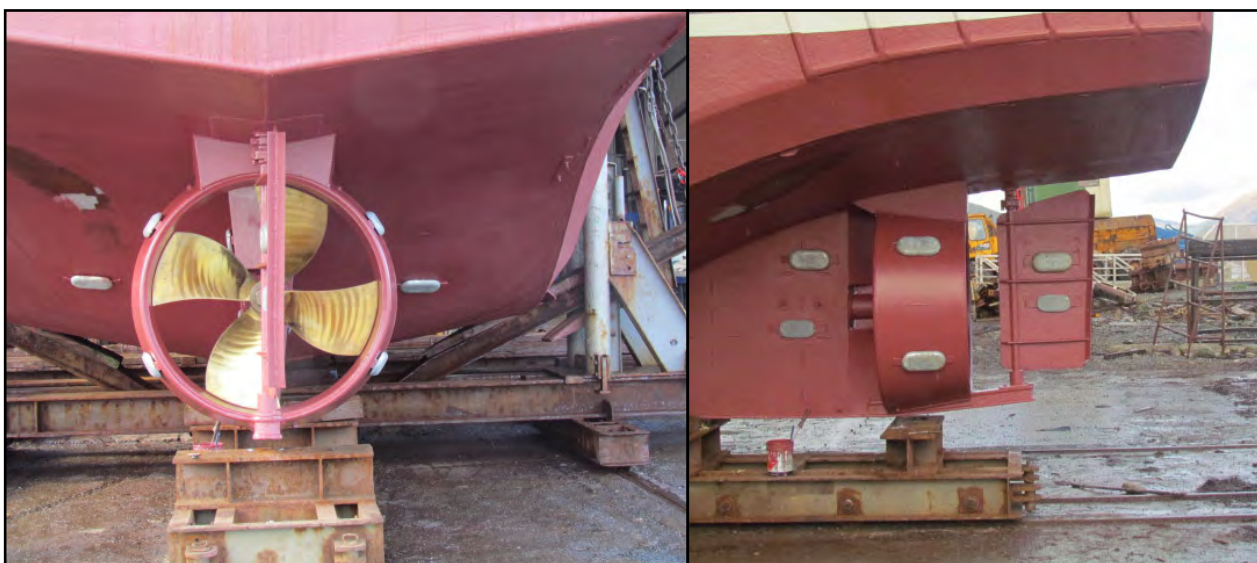
Figure 4b and c: *Nancy Glen* after Kort nozzle fitting

In 2012 the owners decided to replace the propeller and fit a Kort nozzle (**Figures 4a-c**). This comprised a fixed, annular forward extending duct around the propeller. The propeller operated with a small gap between blade tips and the nozzle internal wall. The nozzle ring had a cross-section shaped as a hydrofoil (**Figure 4c**) that improved propeller efficiency and helped to reduce fuel consumption.

the fish hold. The additions to the supporting structure were carried out following informal advice from a naval architect and a boatyard engineer. Although no stability calculations were carried out in respect of the effect of these modifications, the forward fresh water tank was kept full as ballast to counter the stern trim caused by the Kort nozzle.

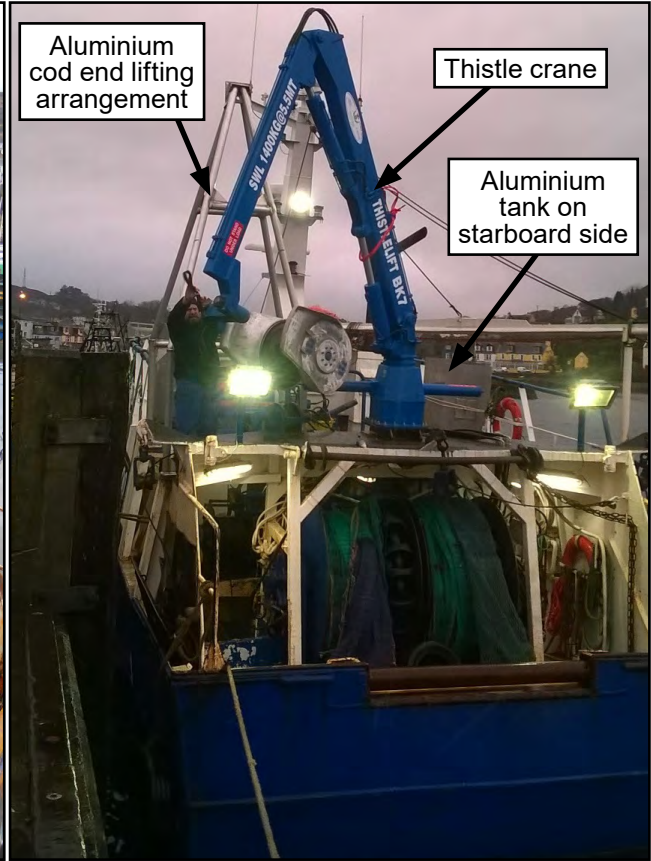
Figure 5b: *Nancy Glen* – replacement Thistle crane

During the 2017/18 Christmas layover, the crane (a Guerra MC 40.55A1) was replaced with a Thistle Marine MKB7 Crane (**Figures 5a** and **5b**). The Guerra crane had a dry weight of 700 kilogramme (kg) while the replacement was more than double the weight, at 1500kg. To compensate for the additional weight the steel cod end lifting post was replaced with an aluminium structure. Although the weight difference was considered, no empirical assessment regarding the effect on the vessel's stability was carried out prior to completing these modifications.

the replacement crane to be similar to the existing one, no action was taken to notify the MCA of the proposed changes or to assess the likely effect on *Nancy Glen*'s stability. These decisions were underpinned by the fact that the owners had assessed the stability when the original Guerra crane had been fitted in 2002.

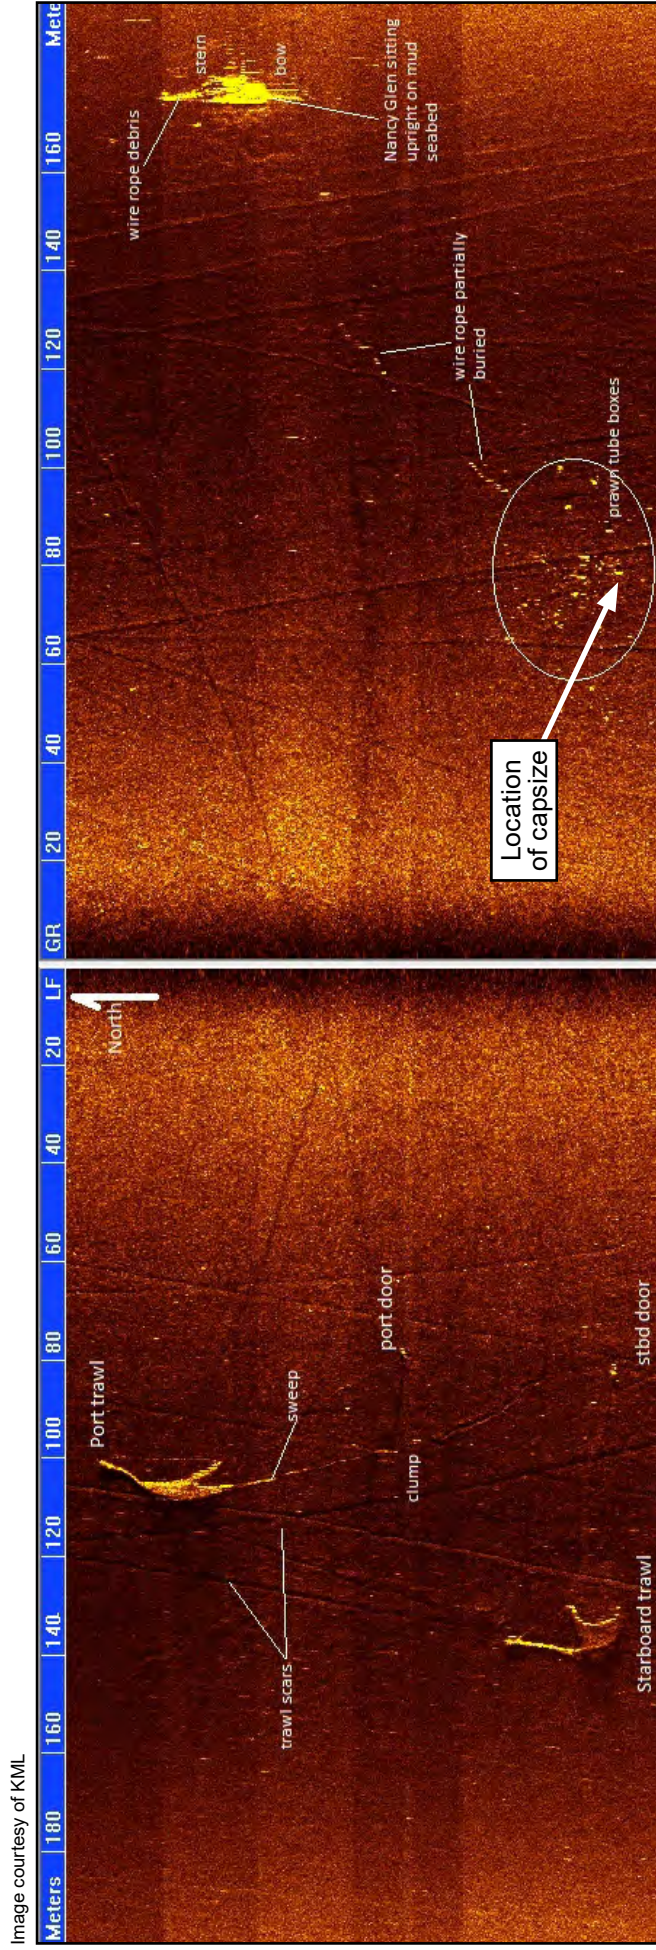
Figure 8: Sonar imagery of seabed showing the debris field, *Nancy Glen* and configuration of the nets

Although the video survey was hampered by poor visibility, images confirmed that the port net was open with the rockhopper ground gear on the seabed and the buoyed headrope floating free. The starboard net was found to be buried with the buoyed headrope lying on the seabed. Further examination indicated that the main body of the starboard net was filled with mud from the seabed (**Figure 9**).

⁷ The trawl gear was lying east/west but the nets had been disturbed through the action of local trawlers assisting in the search post-accident and before the sonar survey was conducted.

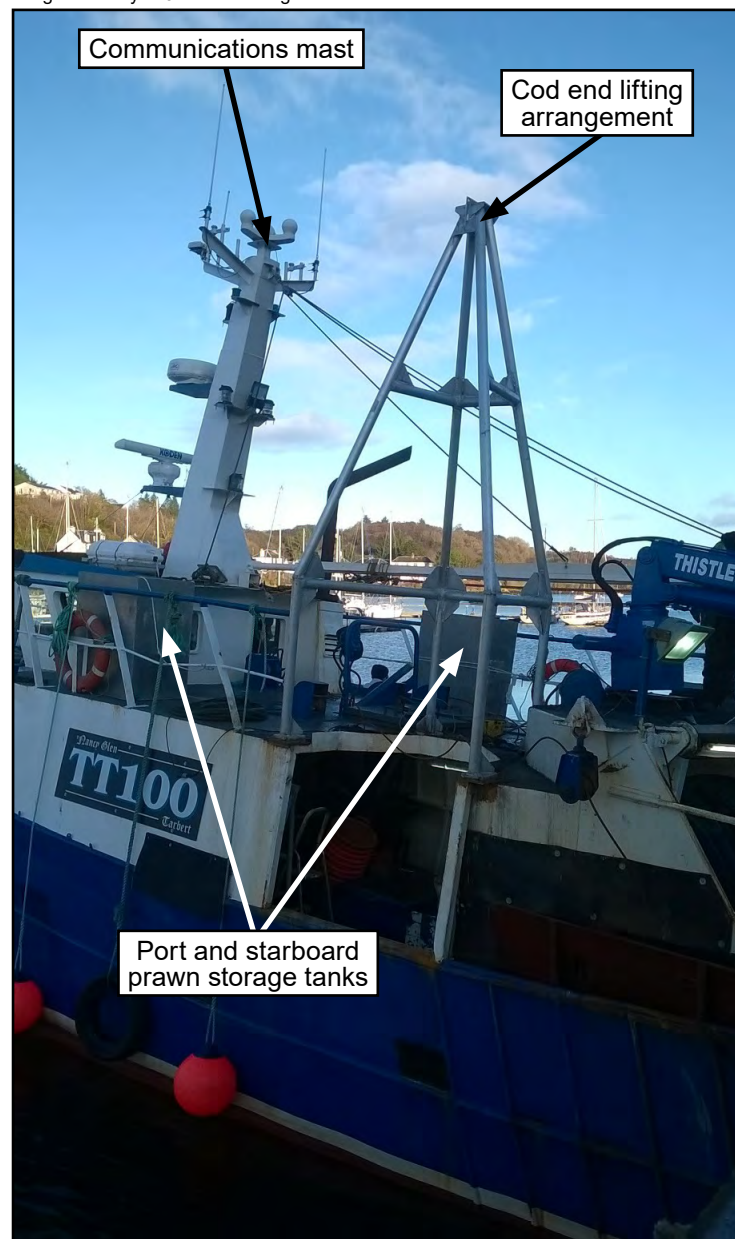
Figure 10: *Nancy Glen* – aluminium prawn storage tanks and lifting arrangement

When using the prawn storage tanks, *Nancy Glen* no longer carried ice in the fish hold. Concurrent with the crane replacement, the cod end lifting arrangement was also modified, replacing steel with aluminium to reduce top weight. The weight of equipment taken off and the equipment added were not recorded (**Figure 10**).

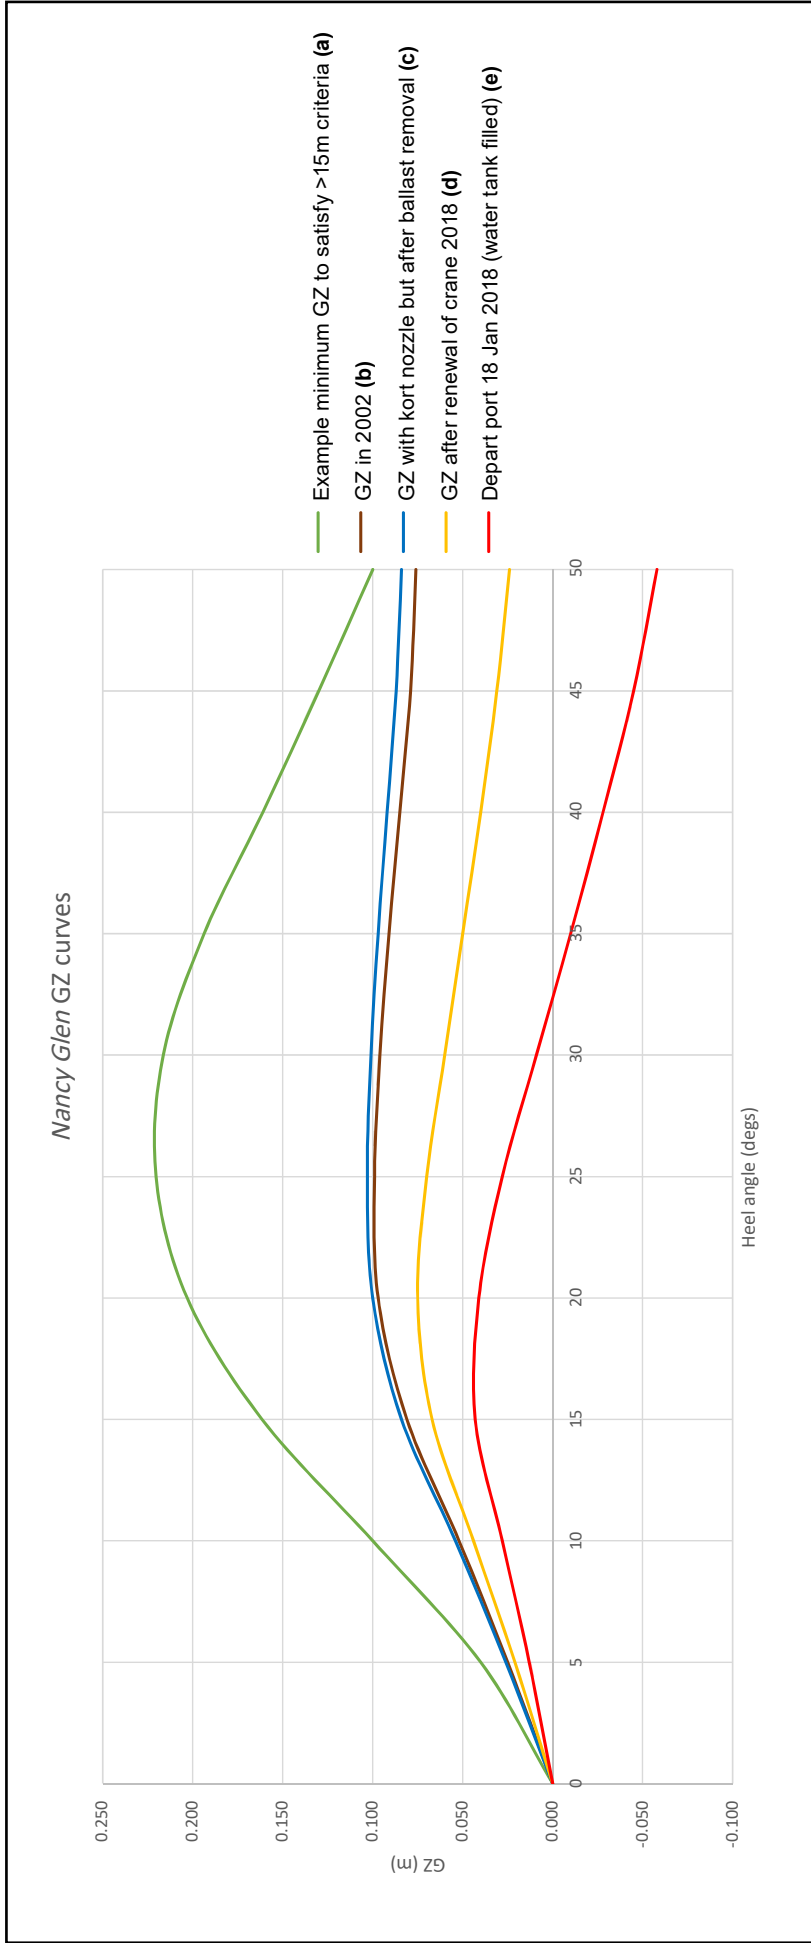
Figure 11: Graph showing a minimum required GZ curve for over 15m LOA fishing vessels compared with results from Nancy Glen calculations

Nancy Glen had operated successfully since the modifications carried out in 2002, and had continued to operate without incident following the various modifications to its structure and equipment. However, the cumulative effect of those modifications, culminating in the replacement of the crane during the 2017/18 Christmas layover, was to reduce the vessel's stability, significantly increasing its vulnerability to capsize.

Figure 11 shows *Nancy Glen*'s GZ curves derived from the 2018 inclining compared with a GZ curve meeting the minimum stability requirements for a vessel over 15m LOA (curve a). The curves b, c and d were calculated with the vessel full of fuel and with ice in the fish hold. Curve e was the estimated departure condition on 18 January 2018 (70% fuel and no ice but with the three prawn tanks full of water).
