Report on the investigation of the
keel failure and capsizing of
the Comar Comet 45 Sport yacht
Tyger of London

1 nautical mile south of Punta Rasca, Tenerife
on 7 December 2017

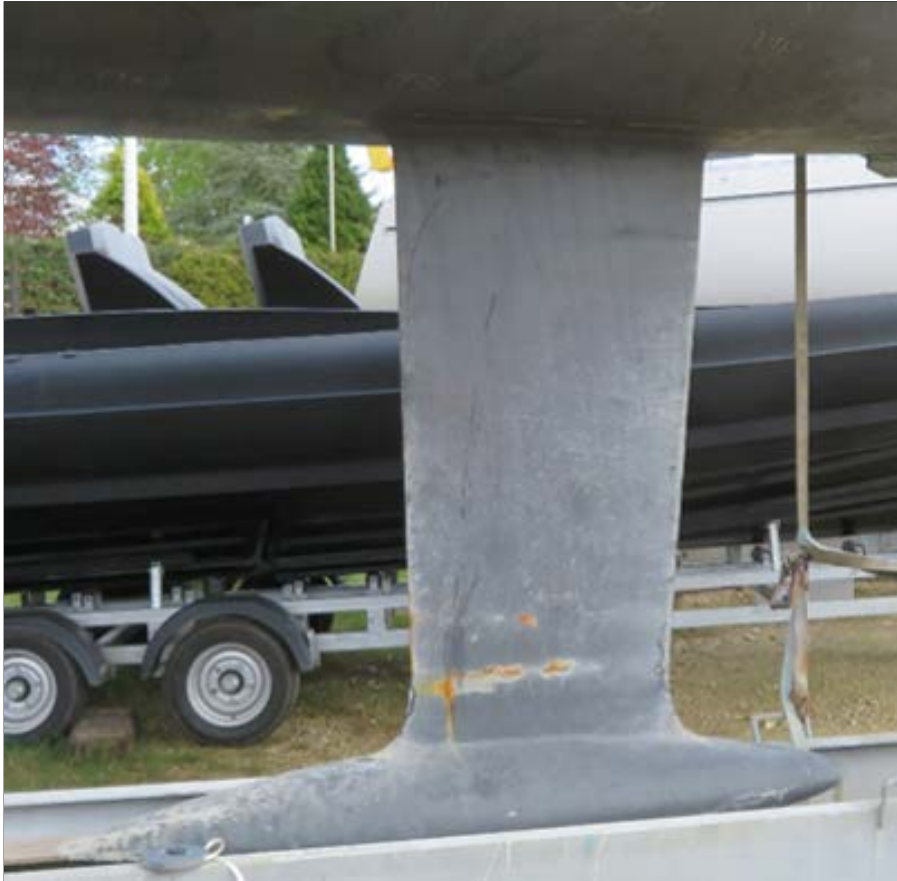
Figure 6: Comar Comet 45S, deep draught racing keel (not fitted to *Tyger of London*)

- A 3200kg deep draught keel, comprising a cast iron fin with a lead bulb fixed to its base (**Figure 6**). This keel extended approximately 2.24m below the hull.
- A 3774kg shallow draught keel, comprising a stainless steel keel plate and frame onto which the lead fin was cast to form the keel (**Figure 7**). This keel, which extended 1.8m below the hull, was aimed at owners who were more interested in cruising or whose home port could not accommodate the deep draught keel.

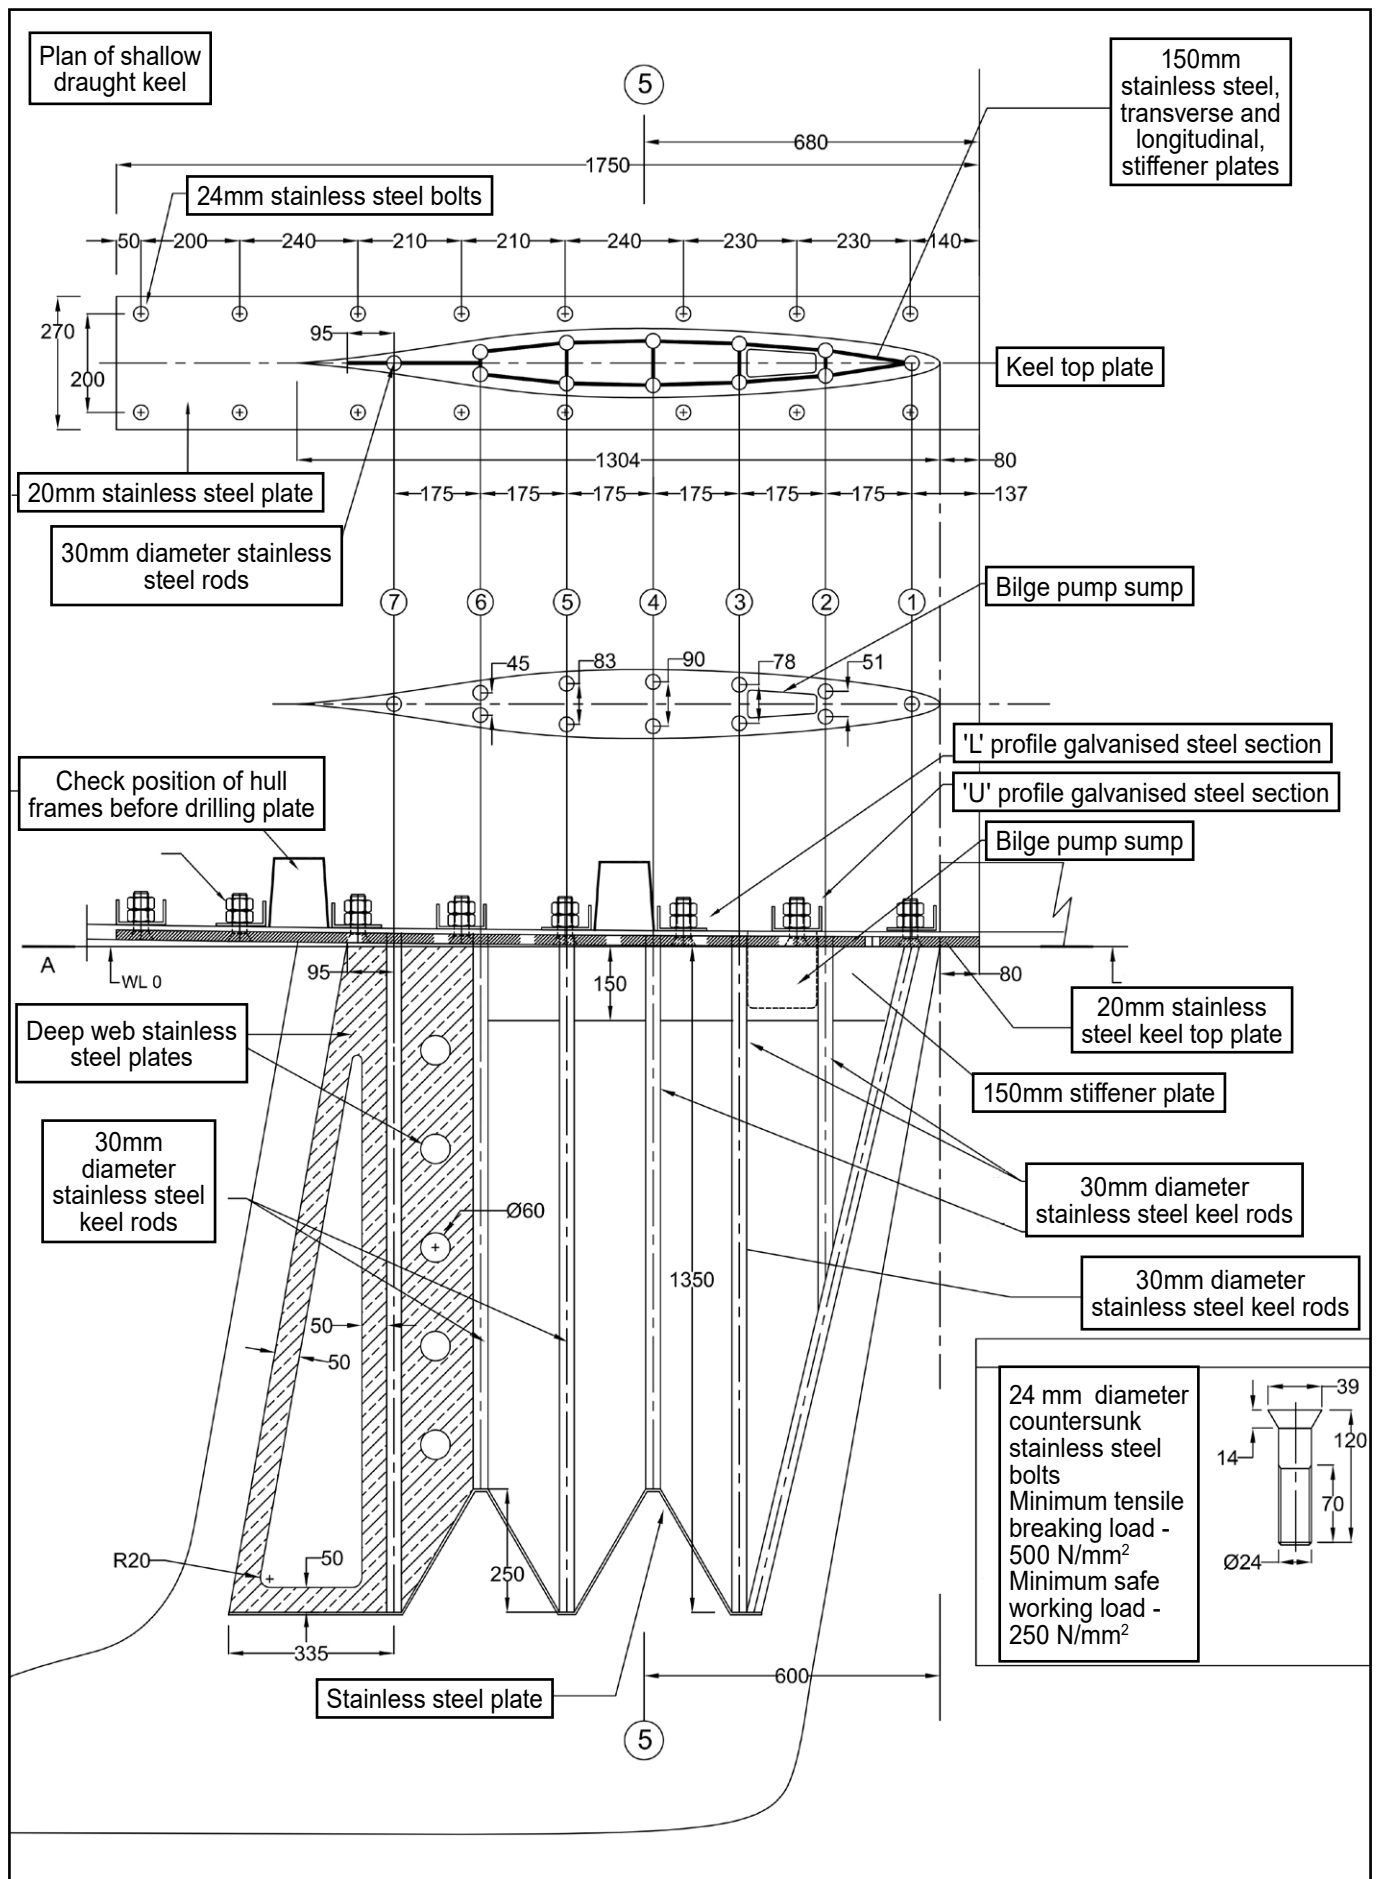
Figure 8: Drawing of Comar Comet 45S shallow draught, lead, cruising keel

The keel drawings (**Figures 8 and 9**) for *Tyger of London's* cruising keel showed:

- A lead keel fin, which was cast around,
- A stainless steel keel frame, made up of: a rectangular top plate into which 12 x 30mm diameter rods were threaded and welded; 150mm interconnecting, transverse and longitudinal stiffener plates welded to the rods, but not to the top plate; and two deep web centre line plates that stiffened the rear of the keel.

After attempting to manufacture the stainless steel frames on one or two occasions as designed, the fabricator proposed some changes to the shipyard. These included changes to the manner in which the 30mm diameter threaded rods were welded to the underside of the stainless steel top plate. Specifically, rather than weld the full circumference of each rod as it passed through the underside of the plate, the fabricator proposed to weld only the outside of each rod, but to extend the weld on to the interconnecting plates (**Figure 9**). It was also agreed that the sump for the bilge pump, shown in the designer's drawings, was not required.

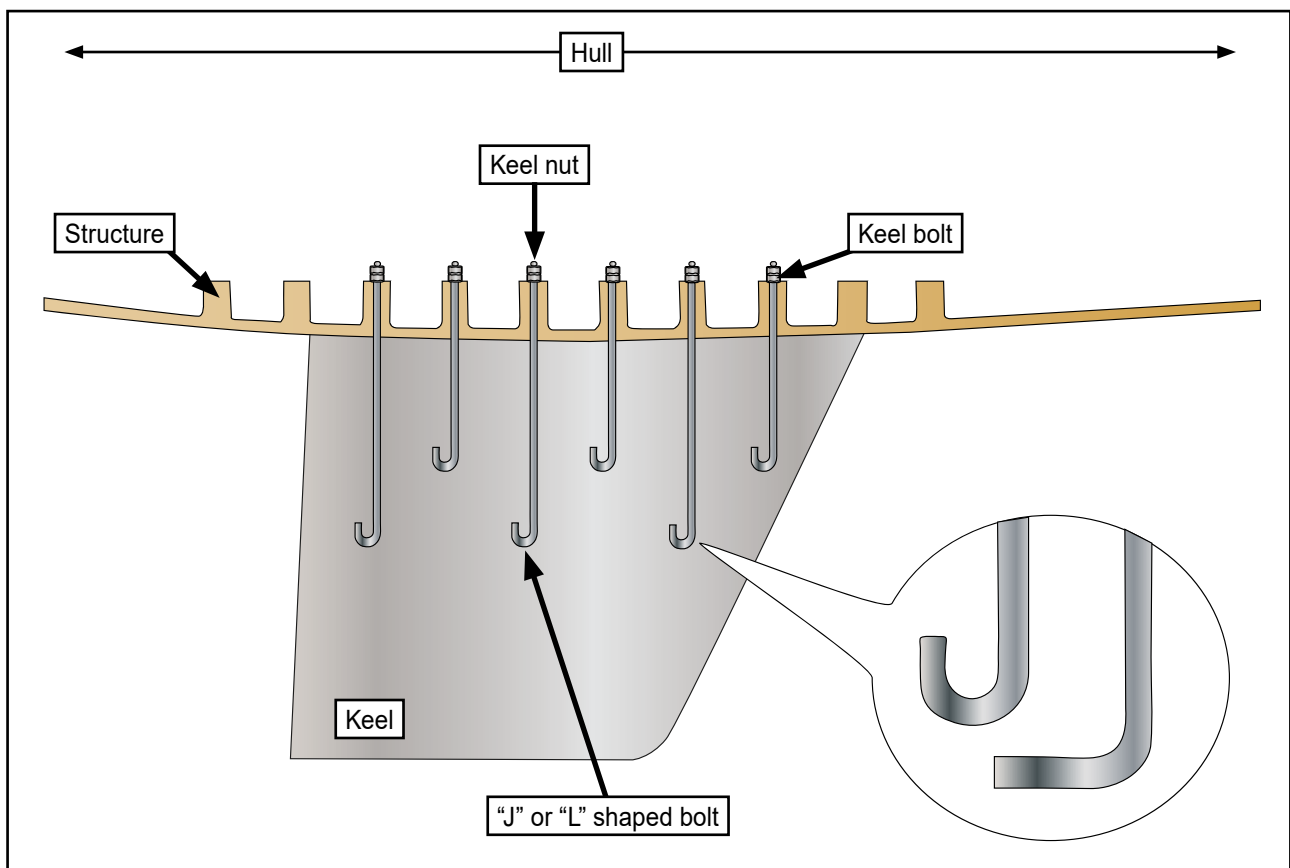
Figure 15: Traditional lead keel

A traditional lead keel is cast around steel 'J' or 'L' shaped keel bolts, the ends of which are then bolted through a yacht's hull structure (**Figure 15**). The benefit of this simple design is that the condition of the hull-to-keel connection can be assessed by observing the keel bolts and ensuring that they are tightly secured with no signs of corrosion. Equally, the keel can be removed to make a more detailed examination of the keel-to-hull connection if required.

In contrast, the unusual design of the Comar Comet 45S shallow draught keel was more complex. Its construction relied on a top plate attached to the yacht using 16 bolts. However, the majority of the 3.7t mass of the keel was hung from 12 rods, threaded and welded to the top plate and hidden within the lead casting.
