Report on the investigation of the
capsize and foundering of the fishing vessel

Nancy Glen (TT100)

Lower Loch Fyne, Scotland

18 January 2018

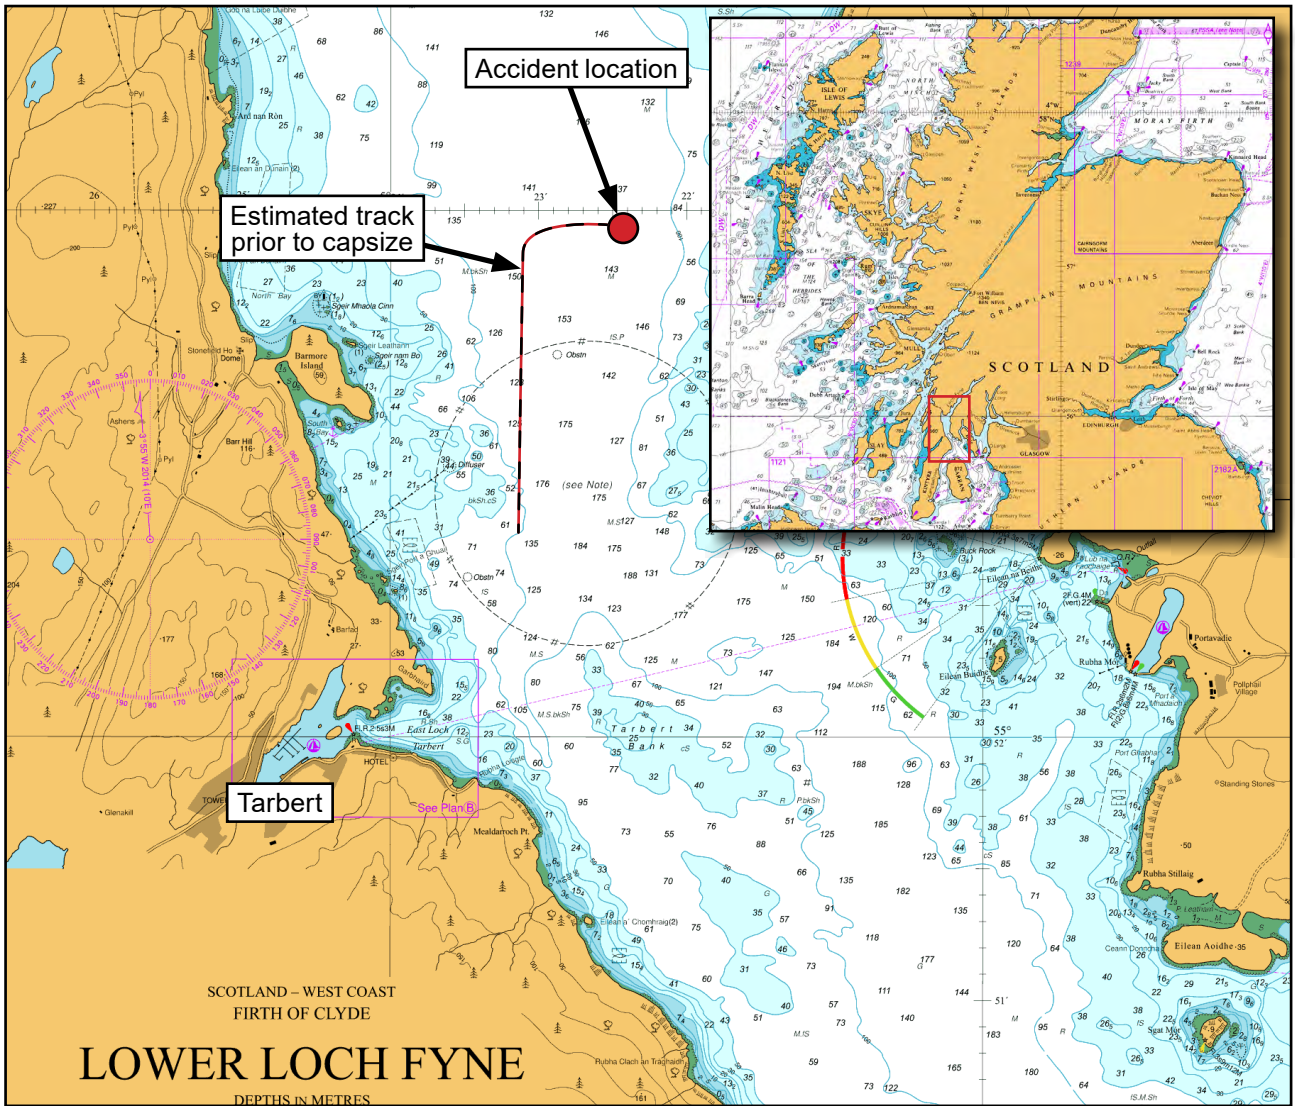
Figure 1: Chart showing *Nancy Glen's* estimated track and the capsizing position with overview inset

At 1800, Coastguard Operations Centre (CGOC) Belfast received a '999' call reporting the capsizing of *Nancy Glen*. This was supported by a digital selective calling (DSC) alert raised by the crew of the fish farm vessel *Lady Inger*. CGOC Belfast broadcast a 'Mayday Relay' at 1819 reporting that the fishing vessel *Nancy Glen* had capsized 1.2nm north-east of Barmore Island (**Figure 1**) with two persons missing.

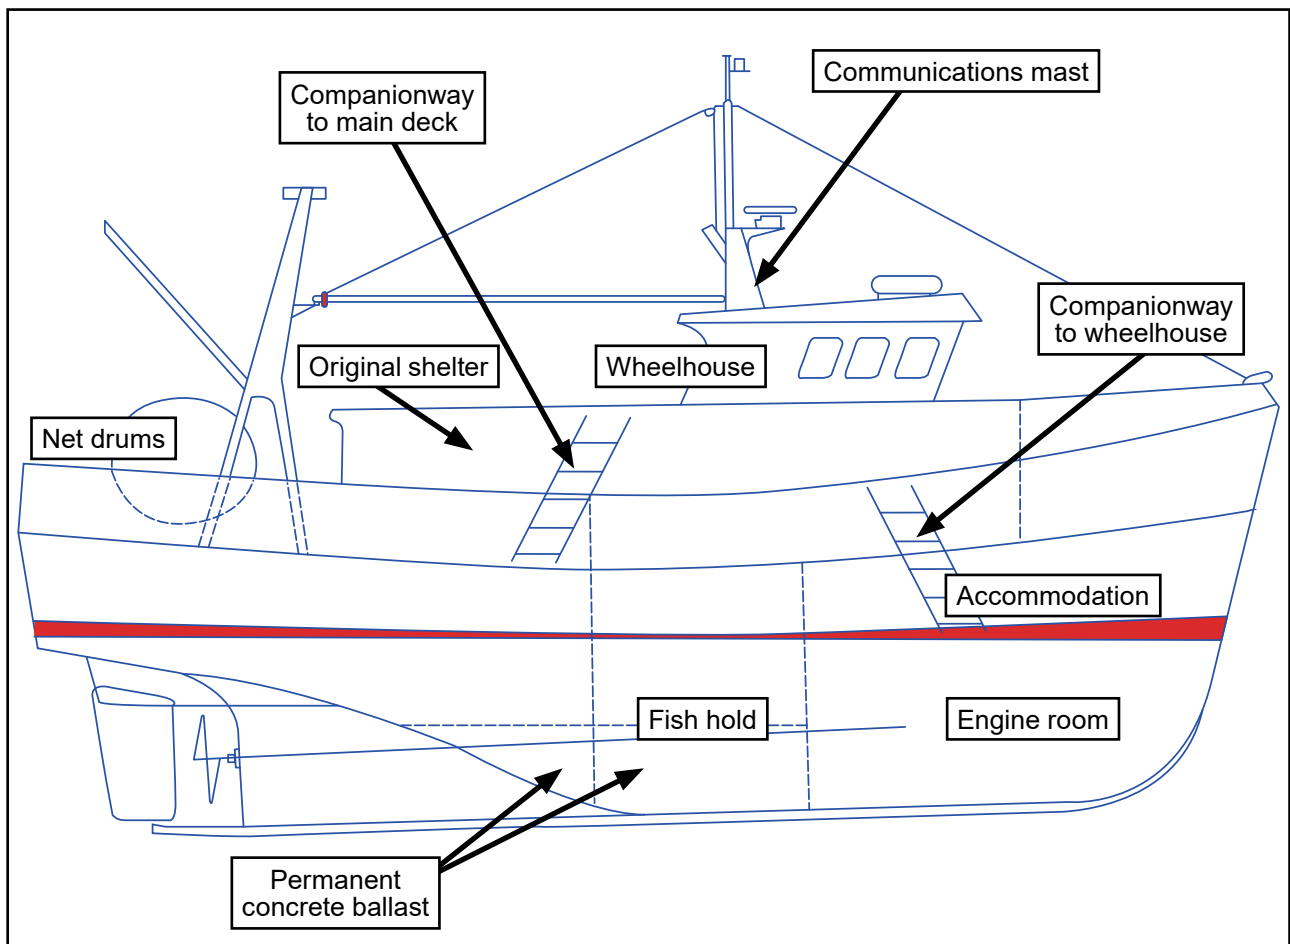
Figure 3: *Nancy Glen* – general arrangement before modifications

Nancy Glen had been designed as a twin rig stern trawler with the wheelhouse at the forward end of the main deck. The accommodation - a four-berth cabin - forward of the wheelhouse was above the engine room. There was a small ventilation hatch in the deckhead of the cabin. The working deck with the main trawl winch and net drums was aft of the wheelhouse. There was an insulated but not refrigerated fish hold aft of the engine room. Access to the wheelhouse was from the main deck via a short companionway. The cabin was accessed from the wheelhouse using a similar companionway and there was a shelter over the main deck, which extended just aft of midships. *Nancy Glen's* original layout is at **Figure 3**. A crane, located at the aft end of the shelter deck, was used for moving nets and catch when the vessel was in harbour.

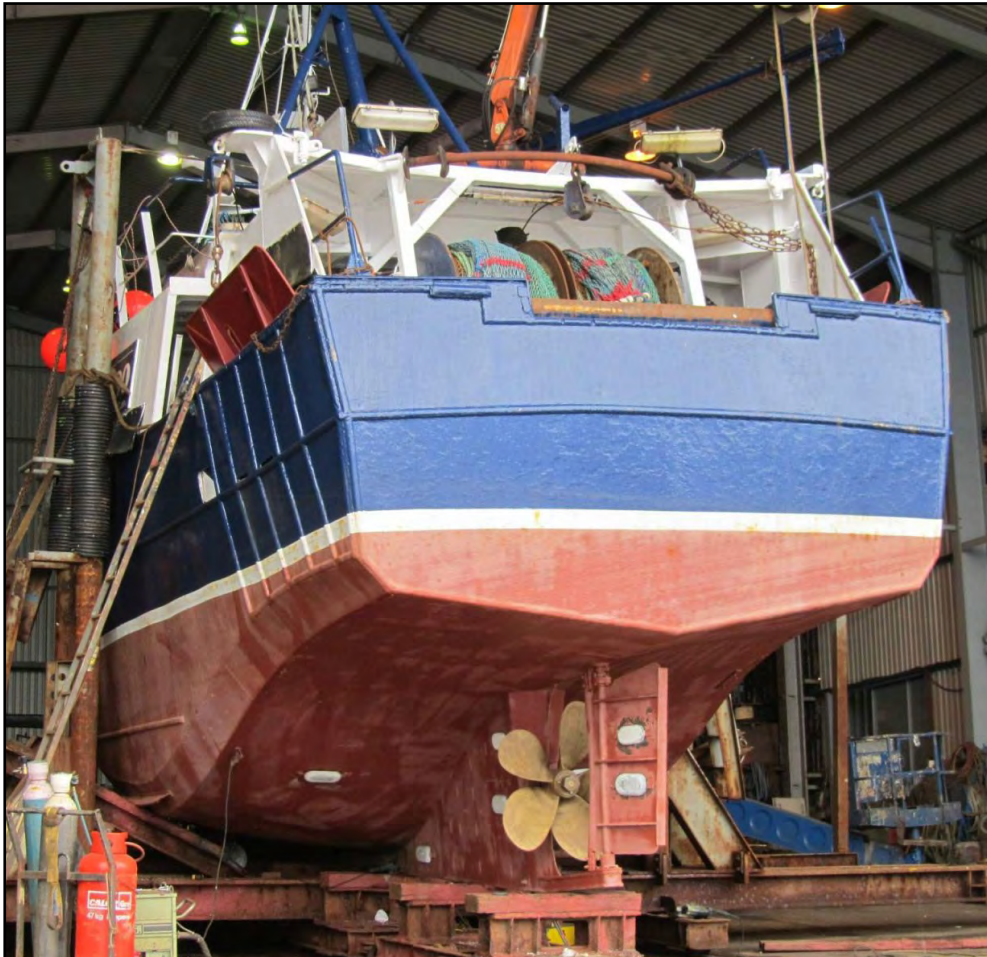
Figure 4a: *Nancy Glen* with original propeller arrangement

In 2012 the owners decided to replace the propeller and fit a Kort nozzle (**Figures 4a-c**). This comprised a fixed, annular forward extending duct around the propeller. The propeller operated with a small gap between blade tips and the nozzle internal wall. The nozzle ring had a cross-section shaped as a hydrofoil (**Figure 4c**) that improved propeller efficiency and helped to reduce fuel consumption.

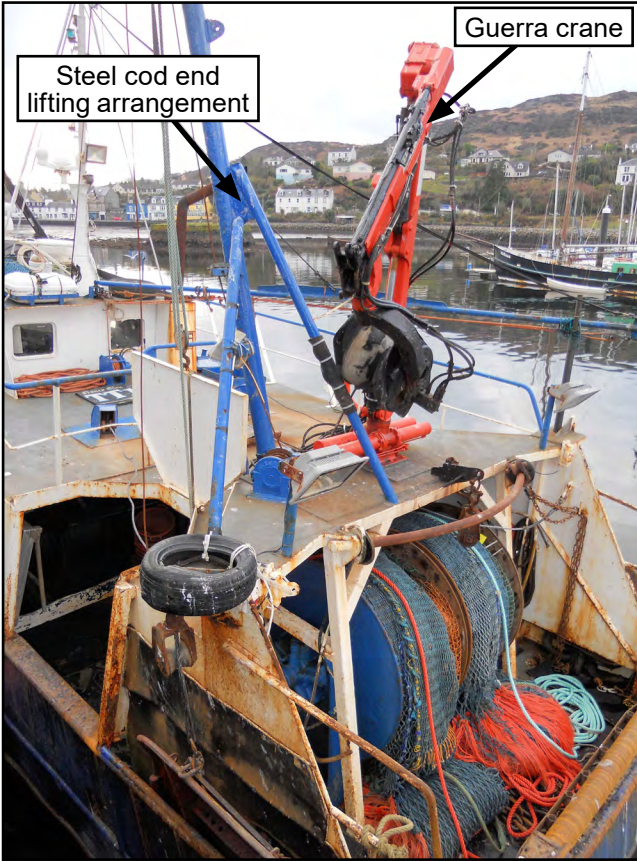
Figure 5a: *Nancy Glen* – previous Guerra crane

During the 2017/18 Christmas layover, the crane (a Guerra MC 40.55A1) was replaced with a Thistle Marine MKB7 Crane (**Figures 5a** and **5b**). The Guerra crane had a dry weight of 700 kilogramme (kg) while the replacement was more than double the weight, at 1500kg. To compensate for the additional weight the steel cod end lifting post was replaced with an aluminium structure. Although the weight difference was considered, no empirical assessment regarding the effect on the vessel's stability was carried out prior to completing these modifications.

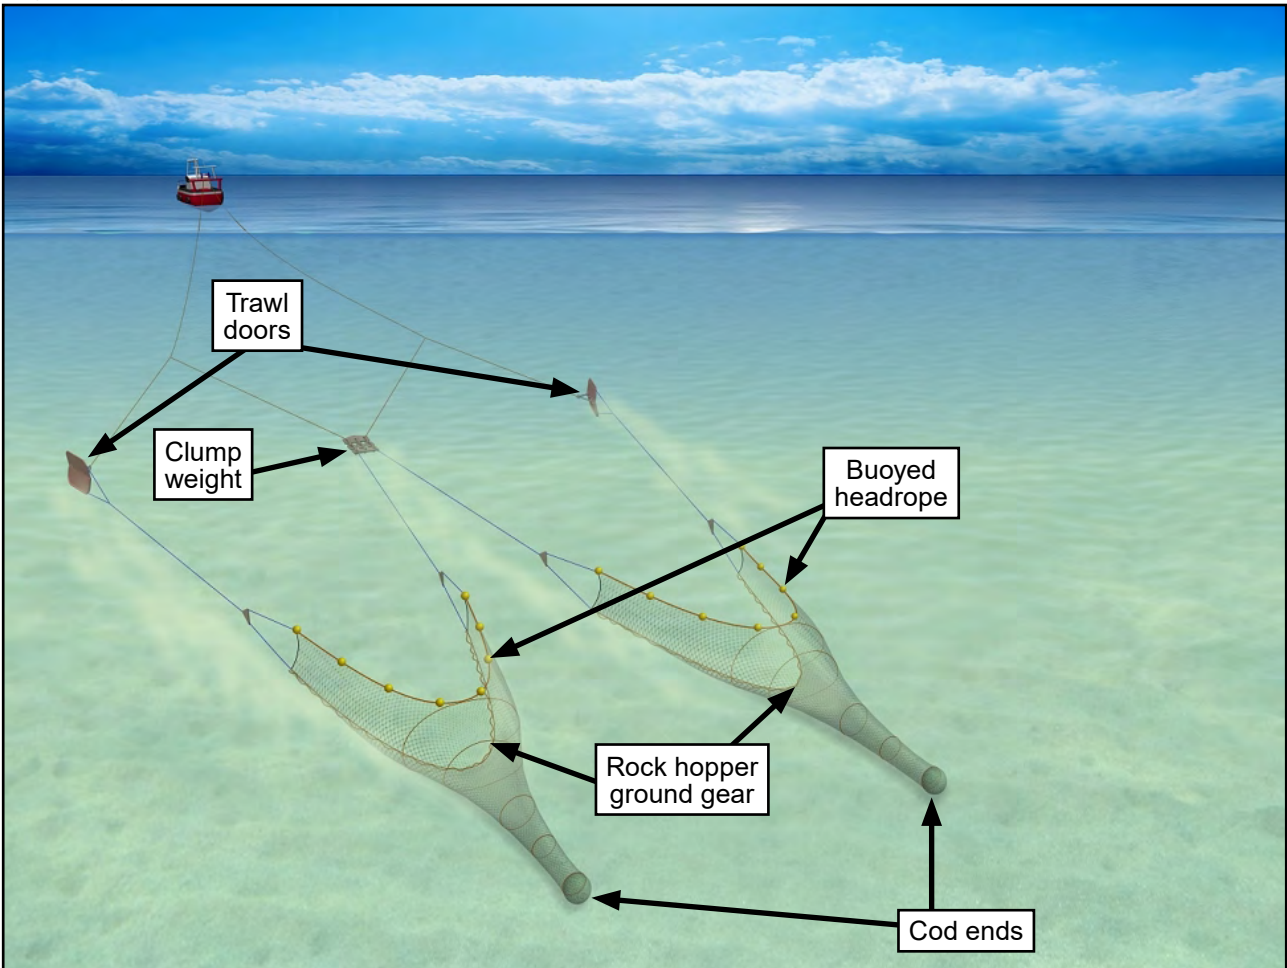
Figure 6: General arrangement of twin rigged prawn trawling

Nancy Glen was configured as a twin rigged prawn trawler with port and starboard nets stored on a split net drum. The Harkness prawn nets had approximately 7.6m of rockhopper disc ground gear connected to rubber covered link chain, giving an overall ground gear length of 17.7m. The nets were connected to 2m Dunbar trawl doors and a 400kg clump weight (**Figure 6**). The towing gear comprised 400m of 14mm rubber covered wire warps.

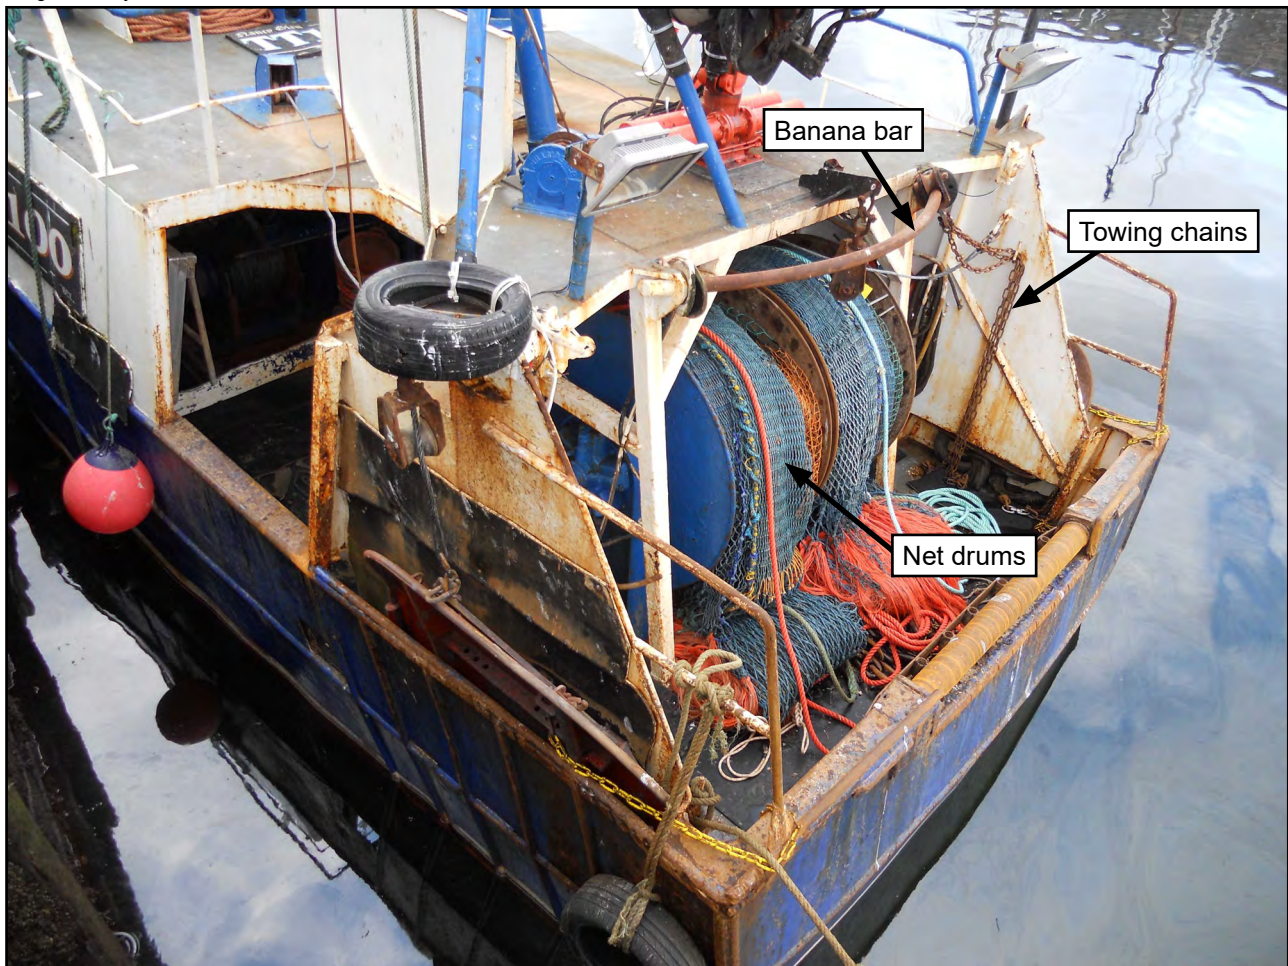
Figure 7: *Nancy Glen's* trawling arrangement showing the net drums, towing chains and banana bar

Once deployed, each of the three warps (two towing warps and the clump weight) was connected to the single towing point on the banana bar using a chain stopper (**Figure 7**). This arrangement allowed the vessel to turn more quickly as the load and the effective towing point was free to move along the bar as the vessel manoeuvred. For trawling in Lower Loch Fyne, approximately 400m of warps were deployed.
